# Manhole Inspection Summary

Manhole # S41W\_\_004MH

**Location** Address: **1101 e. fort ave.**

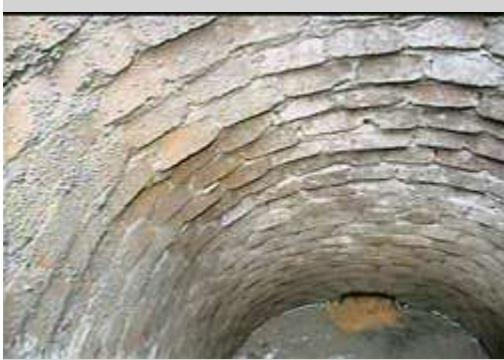
Defect 3

Condition: ☐ Sound ☐ Cracked ☐ Root Intrusion ☐ Deteriorated ☐ Leaks ☒ **Debris**

☒ **Evidence Of Surcharge** Depth: **2** (ft.) ☒ **Active Surcharge Present**

active surcharge, channel debris

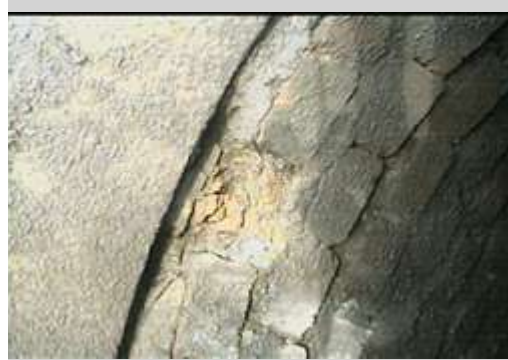
Defect 2

Offset: **1** (in.)

Condition: ☐ Sound ☐ Cracked ☐ Root Intrusion ☒ **Loose Brick** ☐ Deteriorated

frame offset, loose brick in chimney

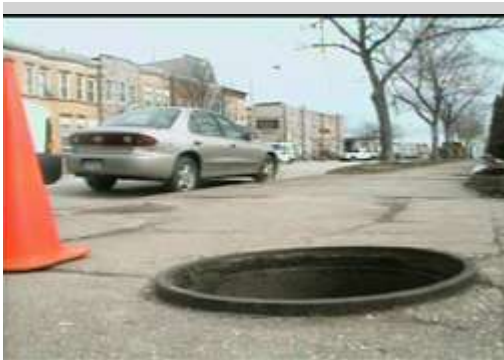
defect 4

Diameter: **26** (in.) Length: **0** (in.) Dist A/B Grade: **1.5** (in.)

frame above grade

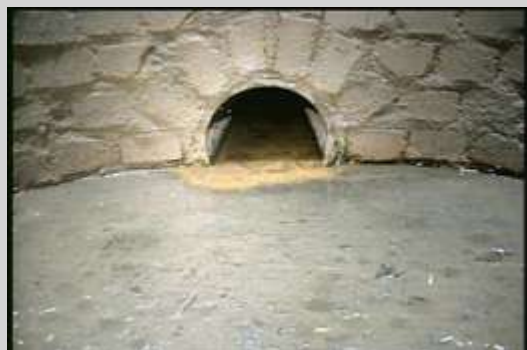
12 O'Clock Outflow

Deposits: ☐ None ☐ Mud ☒ **Gravy** ☐ Debris ☐ Grease

Silt Depth: **2** (in.) Deposits Extent: **Medium**
